Manhole Inspection Summary

Manhole # S33U__011MH

Insp Date: **8/15/08 2:35 PM**

Location Address: **rear 1600 clarkson st**

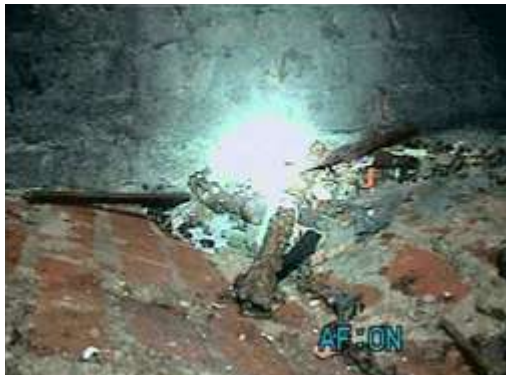
channel debris

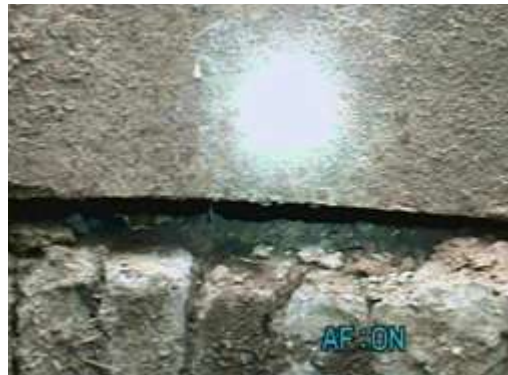
Defect 3

Condition: ☐ Sound ☐ Cracked ☐ Root Intrusion ☒ Loose Brick ☒ Deteriorated

loose bricks, deteriorated, frame adj

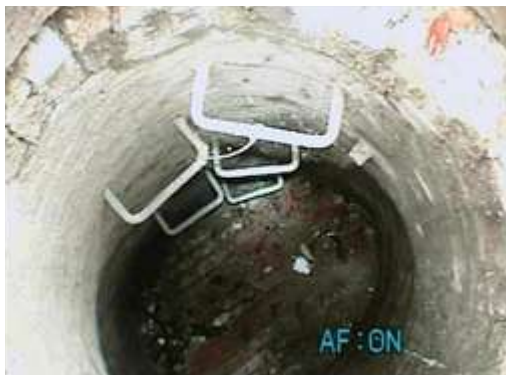
Defect 2

Steps Count: **5** Missing: **0** ☒ Corroded

steps

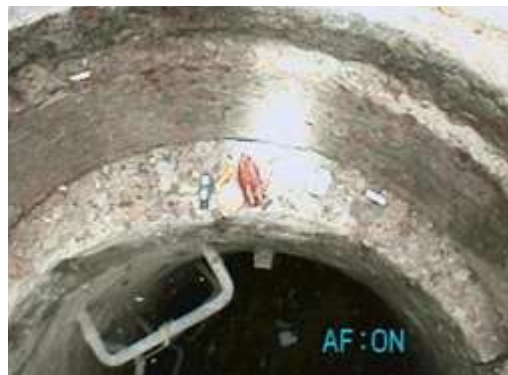
Defect 1

Frame Offset: **3** (in.) Condition: ☒ Sound ☐ Cracked ☐ Leaks

offset
